Roof Assessment and Proposed Solution

South Hill Station - Lexington, KY

Prepared On: 10/16/2025

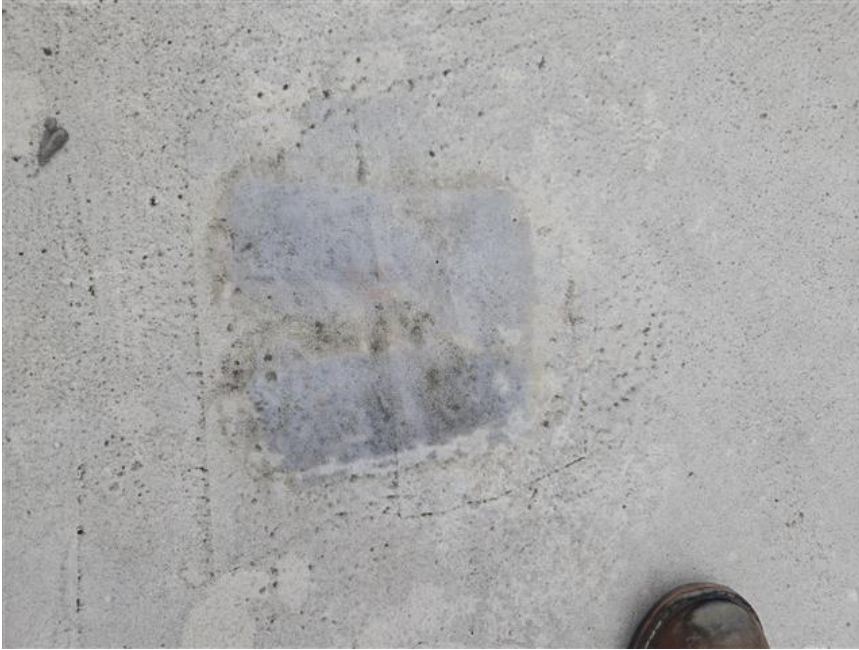
Section: Section 1

Caption: (All) Past Repairs of Existing Roof System

Field of the roof-(Tile) Tiles - Missing

Missing tiles create gaps in your roof that allow water to seep in, causing leaks and water damage to your roof, attic, ceilings, and walls.

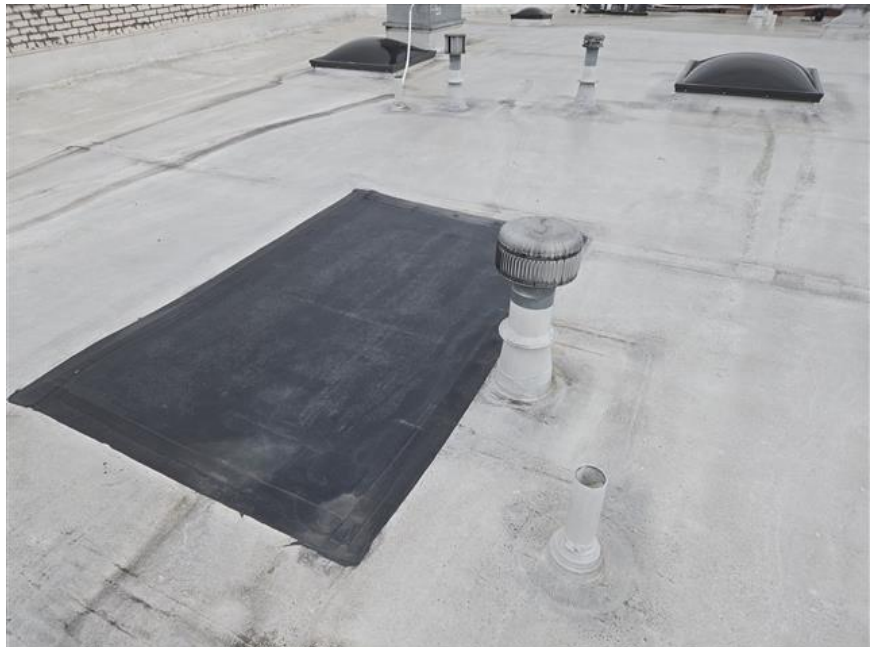
Section: Section 1

Caption: (All) Past Repairs of Existing Roof System

Field of the roof-(Tile) Tiles - Missing

Missing tiles create gaps in your roof that allow water to seep in, causing leaks and water damage to your roof, attic, ceilings, and walls.

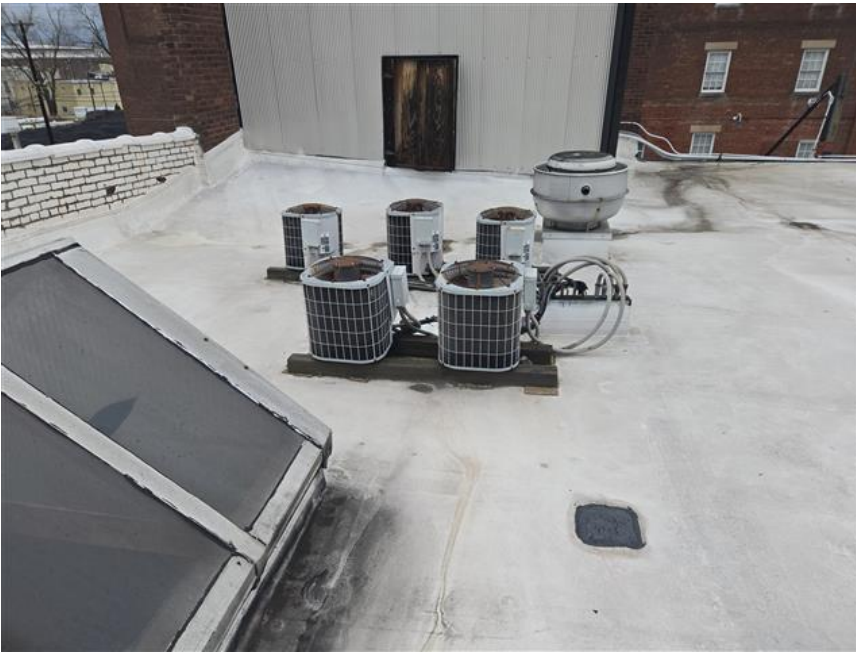
Section: Section 2

Caption: (All) Past Repairs of Existing Roof System

Field of the roof-(Tile) Tiles - Missing

Missing tiles create gaps in your roof that allow water to seep in, causing leaks and water damage to your roof, attic, ceilings, and walls.

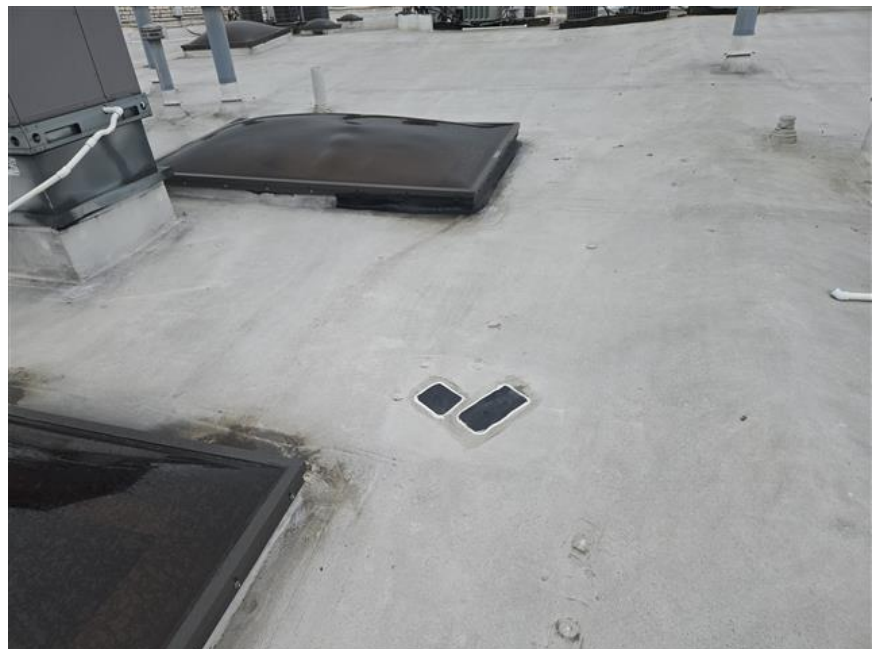
Section: Section 2

Caption: (All) Past Repairs of Existing Roof System

Field of the roof-(Tile) Tiles - Missing

Missing tiles create gaps in your roof that allow water to seep in, causing leaks and water damage to your roof, attic, ceilings, and walls.

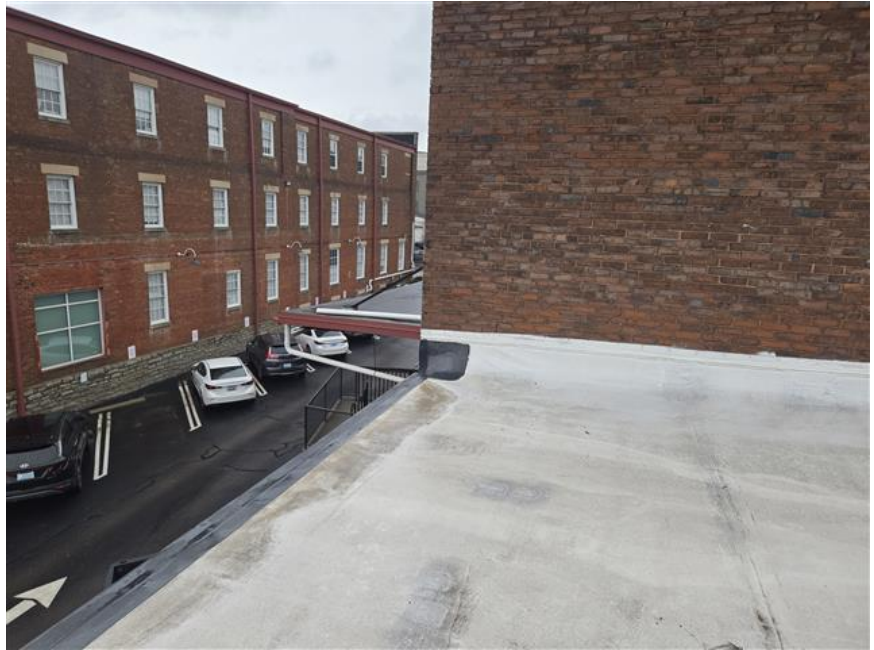
Section: Section 3

Caption: (All) Past Repairs of Existing Roof System

Field of the roof-(Tile) Tiles - Missing

Missing tiles create gaps in your roof that allow water to seep in, causing leaks and water damage to your roof, attic, ceilings, and walls.

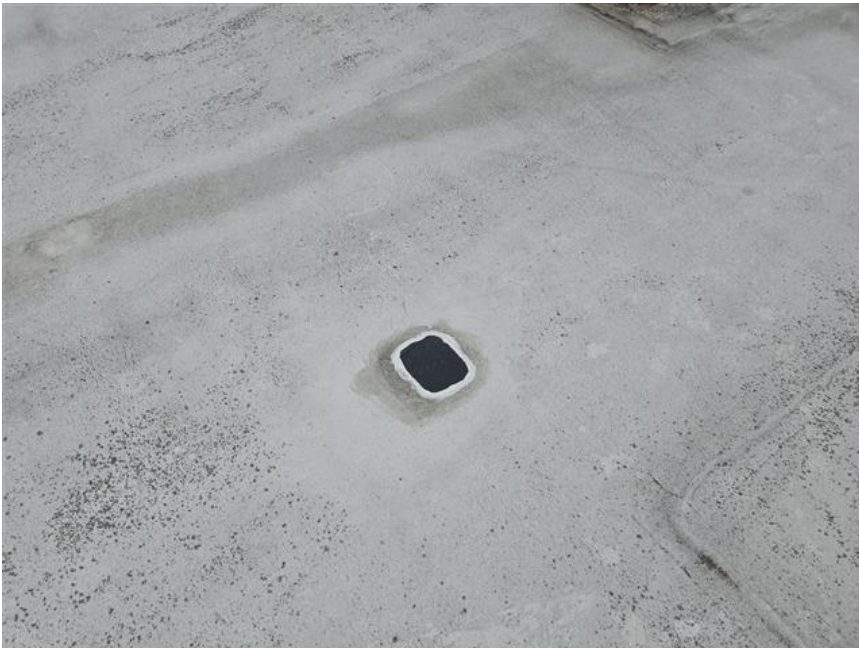
Section: Section 3

Caption: (All) Past Repairs of Existing Roof System

Field of the roof-(Tile) Tiles - Missing

Missing tiles create gaps in your roof that allow water to seep in, causing leaks and water damage to your roof, attic, ceilings, and walls.

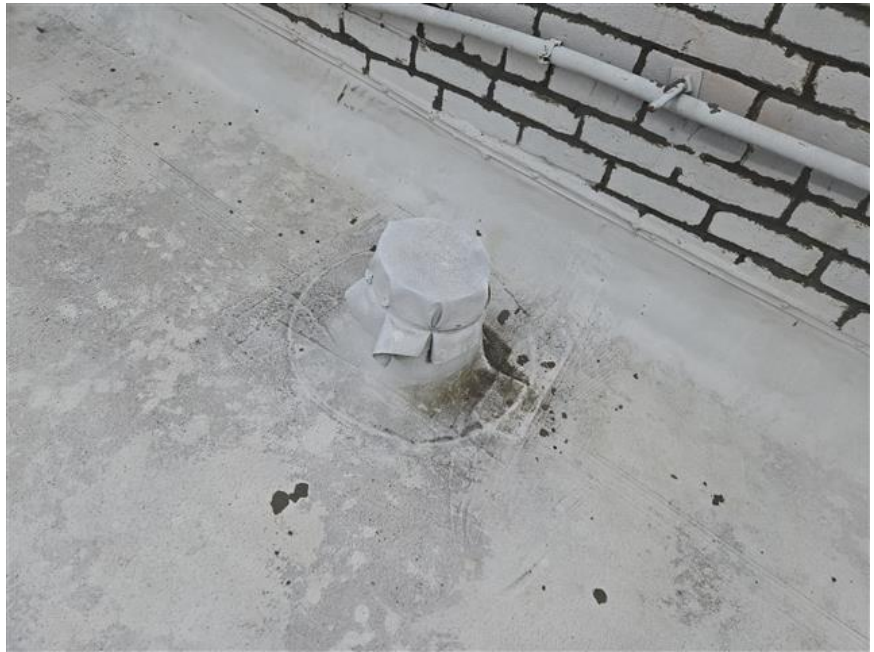
Section: Section 3

Caption: (All) Pipe Flashing Failure

Accessories-(All) Drains - Debris Strainer - Clogged

Clogged debris strainers can result in insufficient drainage and contribute to flashing failure, roof leaks, moisture infiltration into the roof system, deck deflection, or a potential roof collapse during heavy rainfall or snow and ice melt periods.

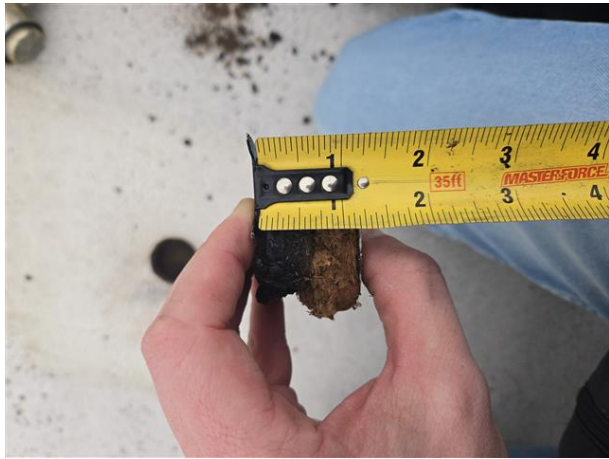
Section: Section 1	Sq. Footage: 12,553	Leaks: Multiple

Roof Condition Summary: We strive to provide our customers with comprehensive information as to their overall roof condition and life expectancy. The roof is in poor condition. A new roof installation is now recommended. This roofing work is suggested now to eliminate the risk of expensive tear off and potential deck replacement associated with continued repairs or re-roofing delays.

MEMBRANE: The field of the roof has clearly reached the end of its life cycle. Previous repairs have been made and further attempts to repair this roof are not recommended.

DETAILS: The details of the roof are in clear need of attention. Repairs should be made to many of the detail areas to prevent further moisture from entering into the roof system.

DECK: The insulation has become saturated in identified areas. This moisture-laden material needs to be removed and replaced immediately to prevent further costly deterioration.

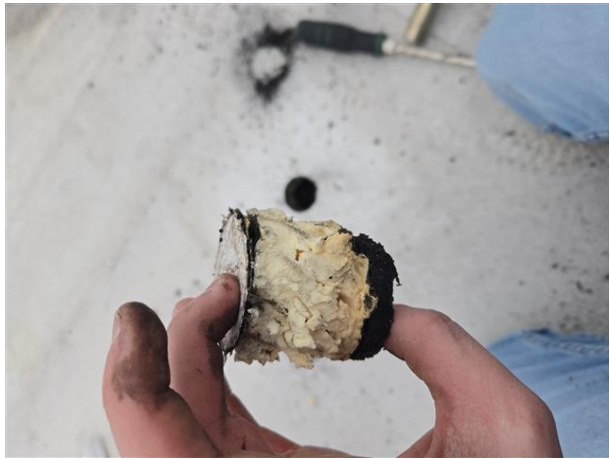
Section: Section 2		Sq. Footage: 12,658	Leaks: Multiple

Roof Condition Summary: We strive to provide our customers with comprehensive information as to their overall roof condition and life expectancy. The roof is in poor condition. A new roof installation is now recommended. This roofing work is suggested now to eliminate the risk of expensive tear off and potential deck replacement associated with continued repairs or re-roofing delays.

MEMBRANE: The field of the roof has clearly reached the end of its life cycle. Previous repairs have been made and further attempts to repair this roof are not recommended.

DETAILS: The details of the roof are in clear need of attention. Repairs should be made to many of the detail areas to prevent further moisture from entering into the roof system.

DECK: The insulation has become saturated in identified areas. This moisture-laden material needs to be removed and replaced immediately to prevent further costly deterioration.

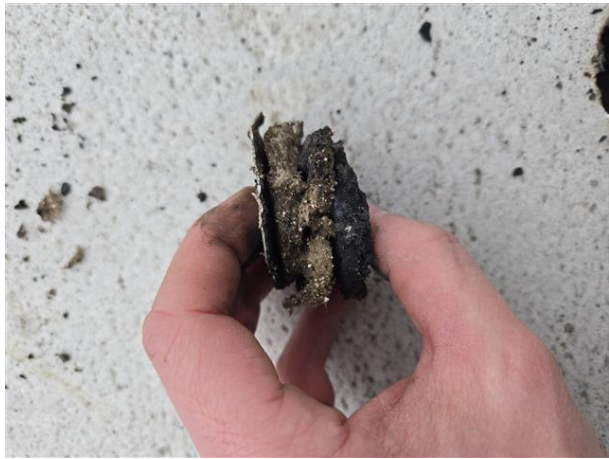
Section: Section 3		Sq. Footage: 11,758	Leaks: Multiple

Core Analysis		
	Layer	Material	Thickness
	Wood T&G	Deck	3.0
	3-Ply Asphalt	BUR (Asphalt)	1.0
	Perlite	Insulation	0.5
	EPDM Fastened	EPDM	0.06
	Core Comments:

Roof Condition Summary: We strive to provide our customers with comprehensive information as to their overall roof condition and life expectancy. The roof is in poor condition. A new roof installation is now recommended. This roofing work is suggested now to eliminate the risk of expensive tear off and potential deck replacement associated with continued repairs or re-roofing delays.

MEMBRANE: The field of the roof has clearly reached the end of its life cycle. Previous repairs have been made and further attempts to repair this roof are not recommended.

DETAILS: The details of the roof are in clear need of attention. Repairs should be made to many of the detail areas to prevent further moisture from entering into the roof system.

DECK: The insulation has become saturated in identified areas. This moisture-laden material needs to be removed and replaced immediately to prevent further costly deterioration.

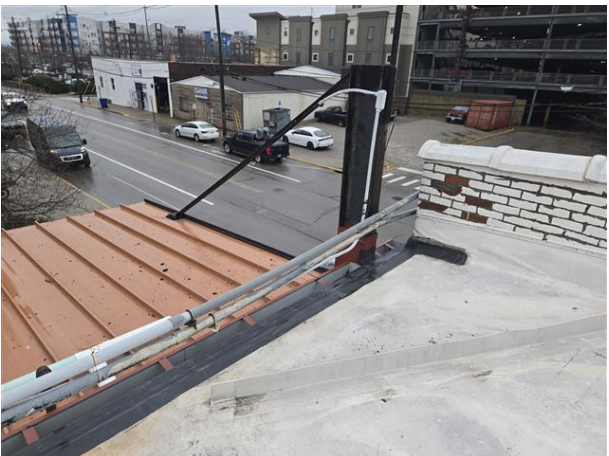
Section: Metal Roof	Sq. Footage: 528	Leaks: Unknown

Roof Condition Summary: We strive to provide our customers with comprehensive information as to their overall roof condition and life expectancy. The roof is in poor condition. As a short-term measure, repairs are needed. It is also suggested that near future roofing work be budgeted.

DETAILS: The details of the roof are in clear need of attention. Repairs should be made to many of the detail areas to prevent further moisture from entering into the roof system.

DECK: The current roof assembly did not utilize roof insulation.

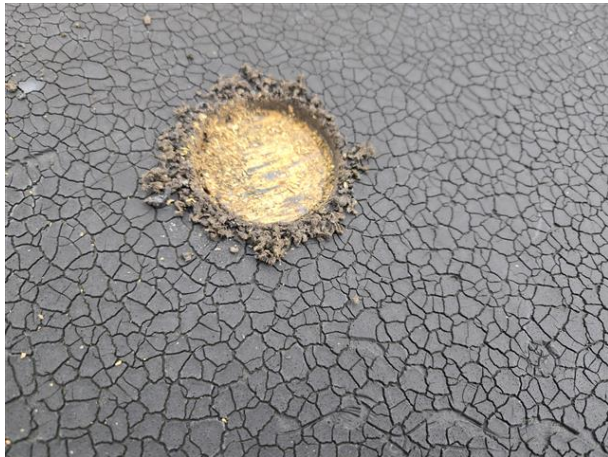
Section: Canopy		Sq. Footage: 1,437	Leaks: Unknown

Core Analysis		
	Layer	Material	Thickness
	Plywood	Deck	0.75
	2-Ply Asphalt	BUR (Asphalt)	0.25
	Core Comments:

Roof Condition Summary: We strive to provide our customers with comprehensive information as to their overall roof condition and life expectancy. The roof is in poor condition. A new roof installation is now recommended. This roofing work is suggested now to eliminate the risk of expensive tear off and potential deck replacement associated with continued repairs or re-roofing delays.

MEMBRANE: The field of the roof has clearly reached the end of its life cycle. Previous repairs have been made and further attempts to repair this roof are not recommended.

DETAILS: The details of the roof are in clear need of attention. Repairs should be made to many of the detail areas to prevent further moisture from entering into the roof system.

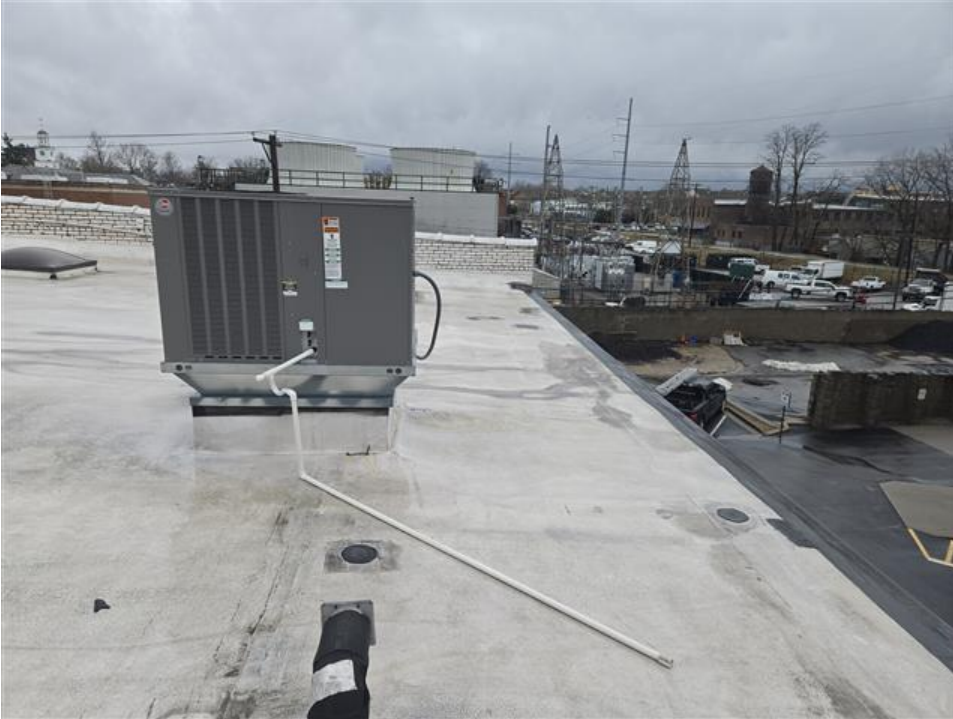
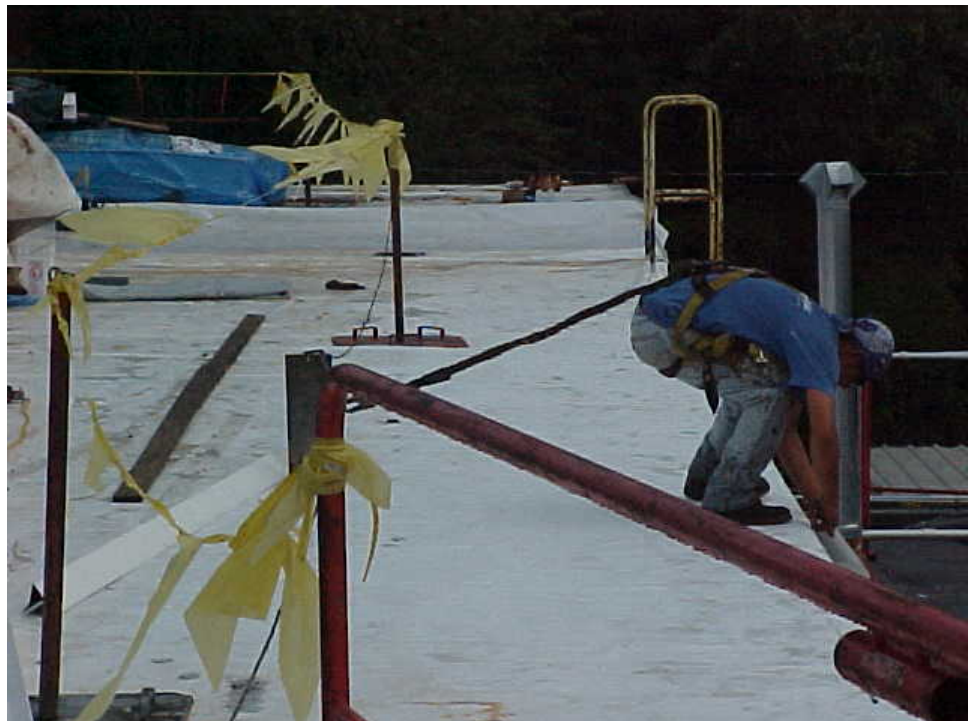
Section: Section 3

Flags & MSS - Edge MSS

Exposed Edges - Fall Hazard

Centimark employee could fall off the edge resulting in serious injury or death.

Run a 3/8 inch cable, 7ft back from edge, to prevent employee, wearing a 6ft lanyard, from reaching the fall hazard but still allowing work to be done on the edge.
