STRUCTURAL INSPECTION REPORT

*585 S Upper St, Lexington, KY 40508
South Hill Station*

Prepared by:
S & W Engineering LLC
4865 Todds Road, Lexington, KY 40509
(606) 471-8017 — (405) 482-9680
bwest@swengineering.us — dsparks@swengineering.us
October 24, 2025

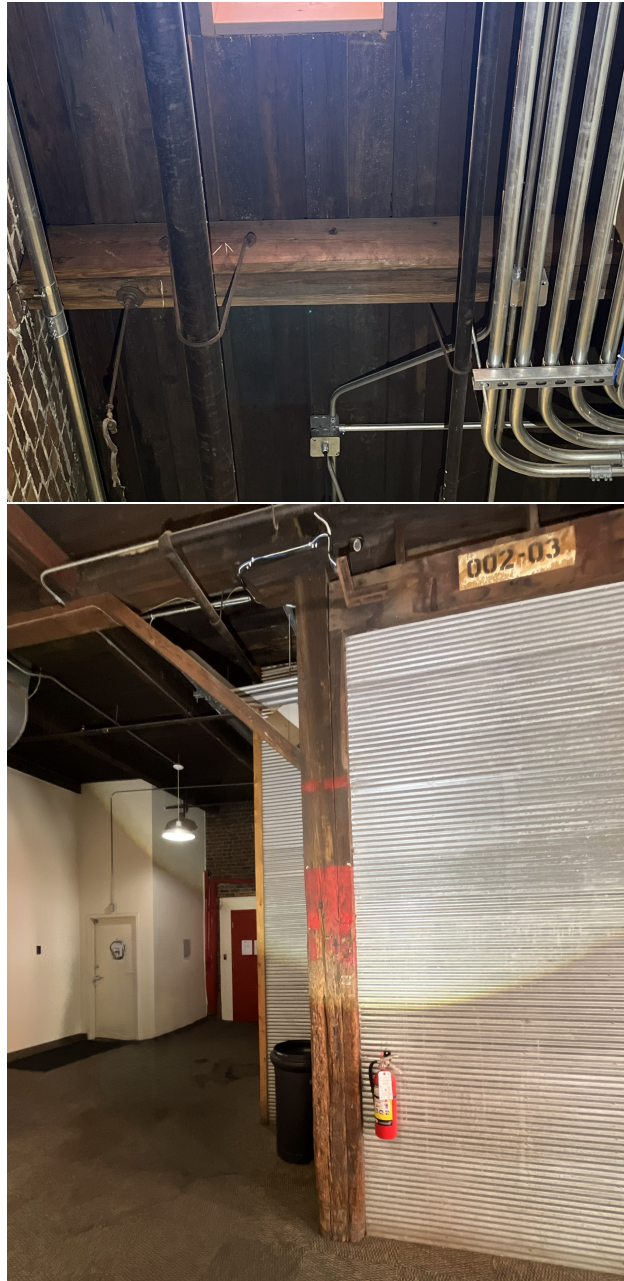
The roof beams and primary framing members were accessible in limited areas. Within these locations, the beams appeared structurally sound with no visible signs of distress, deflection, or cracking. All observed framing members (Exhibit 1) appeared to be in satisfactory condition at the time of the inspection.

Exhibit 1: Roof Beam and Post

2. During replacement of the surrounding roof decking, the roof beams and framing members should be further inspected once exposed. If any beams are found to be damp, corroded, or show signs of degradation, we recommend replacing the affected beams to ensure continued structural integrity.

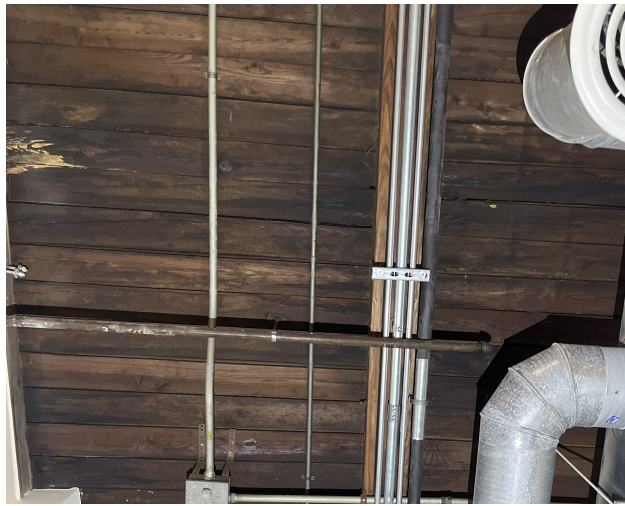
The underside of the roof decking was visible from certain interior locations, seen in Exhibit 2, though direct access to it was limited. From these vantage points, the decking appeared dark and damp in color, suggesting prolonged moisture exposure. Additionally, several soft spots were noted on the roof surface during the inspection. Based on these observations, it is likely that portions of the roof decking have been negatively impacted by roof leaks and moisture intrusion. The decking should be replaced in areas where it is determined to be water damaged.

Exhibit 2: Roof Decking

1. Replace roof decking in all areas where water damage or deterioration is present. Address any active roof leaks contributing to the observed soft spots to prevent future structural degradation.

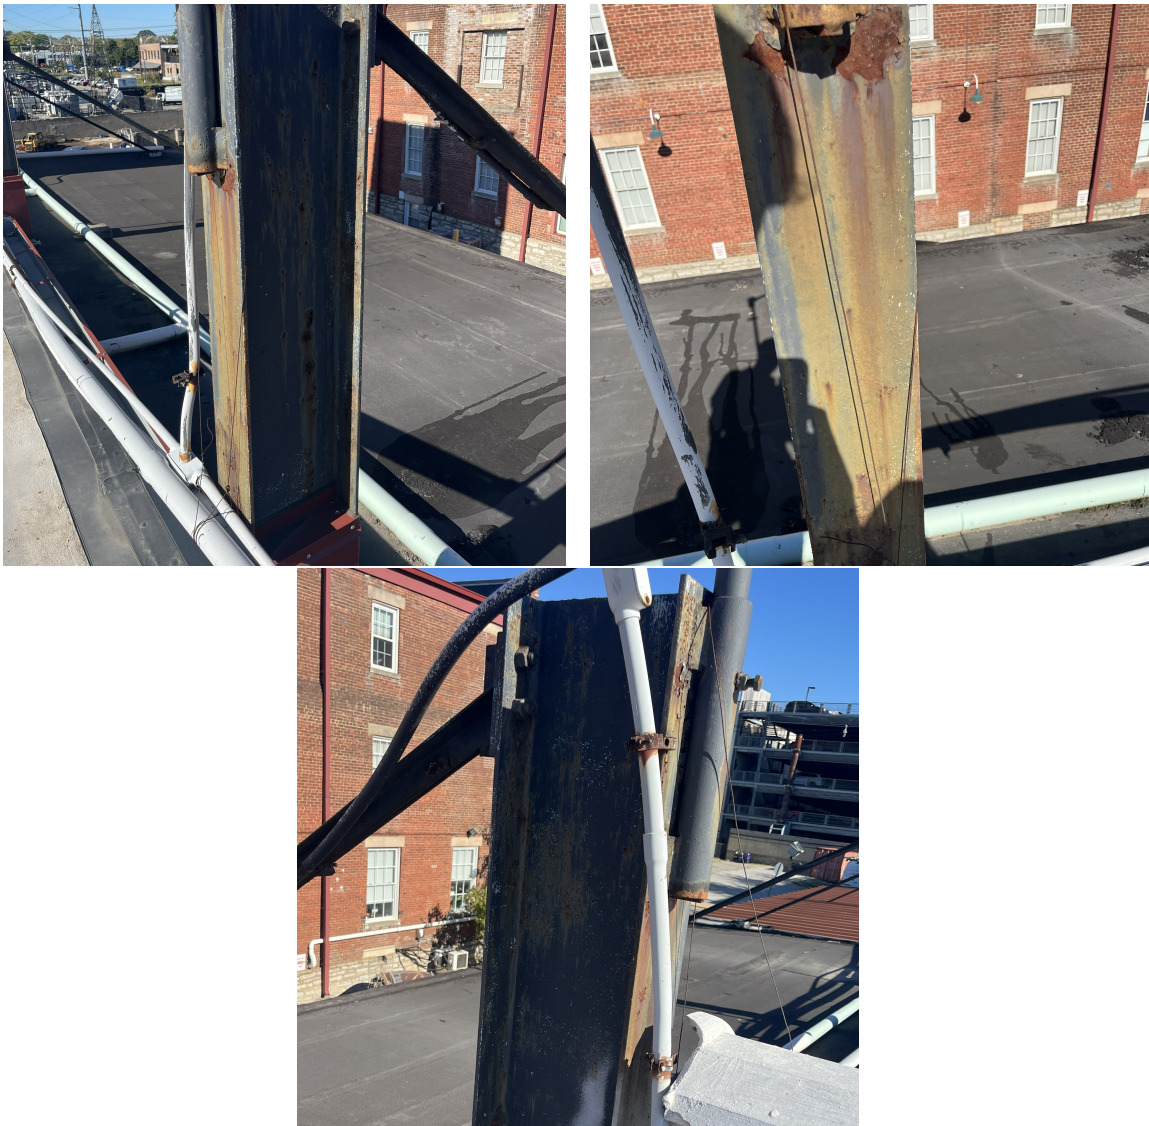
Minor surface rust was noted on the vertical steel I-beam posts, seen in Exhibit 3. The corrosion appears superficial and has not compromised the structural capacity of the members at this time.

Exhibit 3: Rust on Steel Posts

3. Sand and repaint the steel I-beam posts to prevent further corrosion.
4. Properly seal the roof-to-canopy transition area to prevent water from flowing down the brick wall and contributing to long-term moisture damage to the wall or foundation.

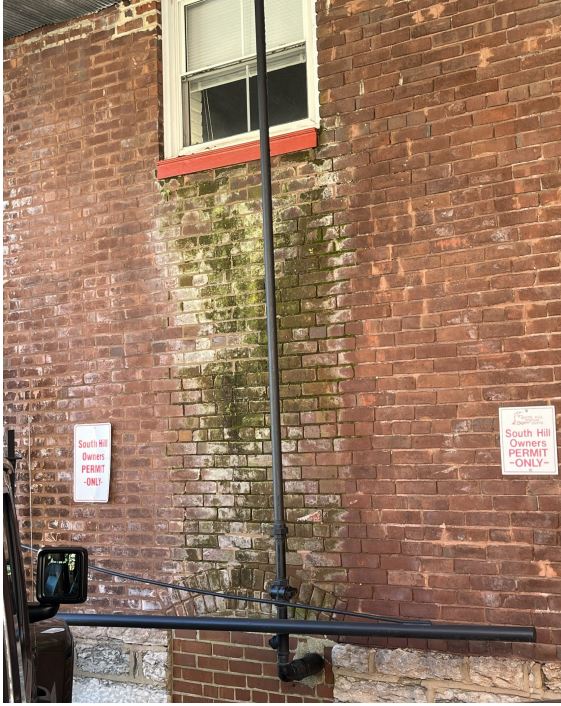
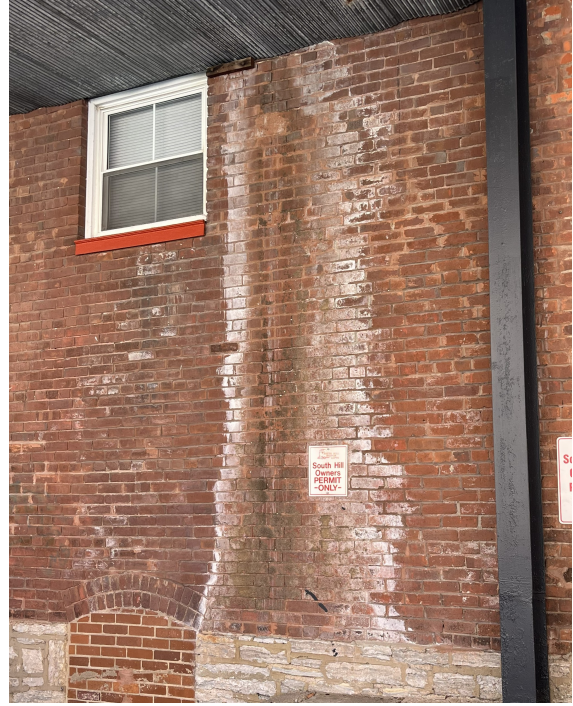
Moisture was observed along the brick wall, seen in Exhibit 4, where the canopy meets the roof transition. This moisture intrusion may continue to deteriorate the brick and potentially impact the foundation if not addressed.

Exhibit 4: Moisture of Brick Wall

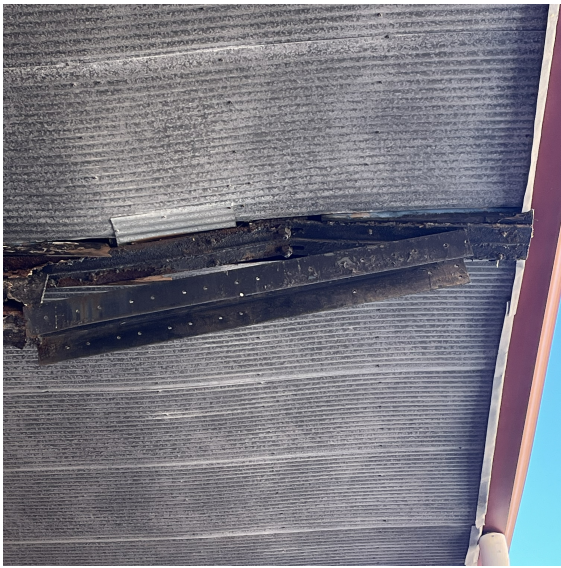
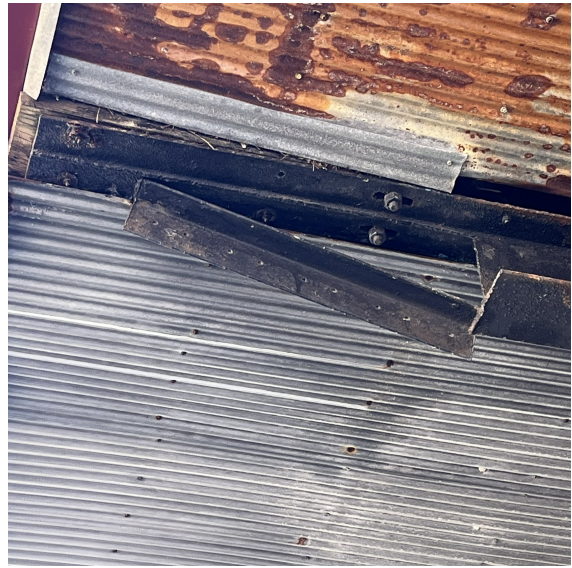
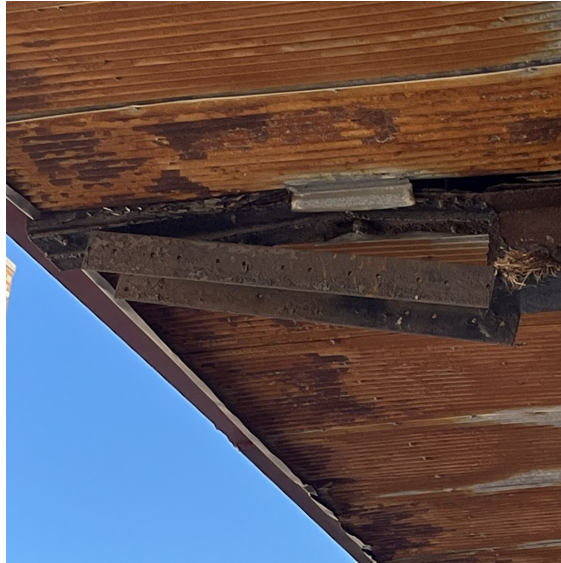
Five (5) out of the eight (8) steel I-beams at the ceiling level have undergone significant modifications, shown in Exhibit 5. A portion of each beam—up to approximately six (6) feet—has been removed and replaced with one to two steel angles. These alterations significantly reduce the original load-carrying capacity of the members.

Exhibit 5: Altered Steel Beams

5. Replace all modified steel I-beams (five total) with new beams of equivalent or greater structural capacity to restore integrity to the awning system.

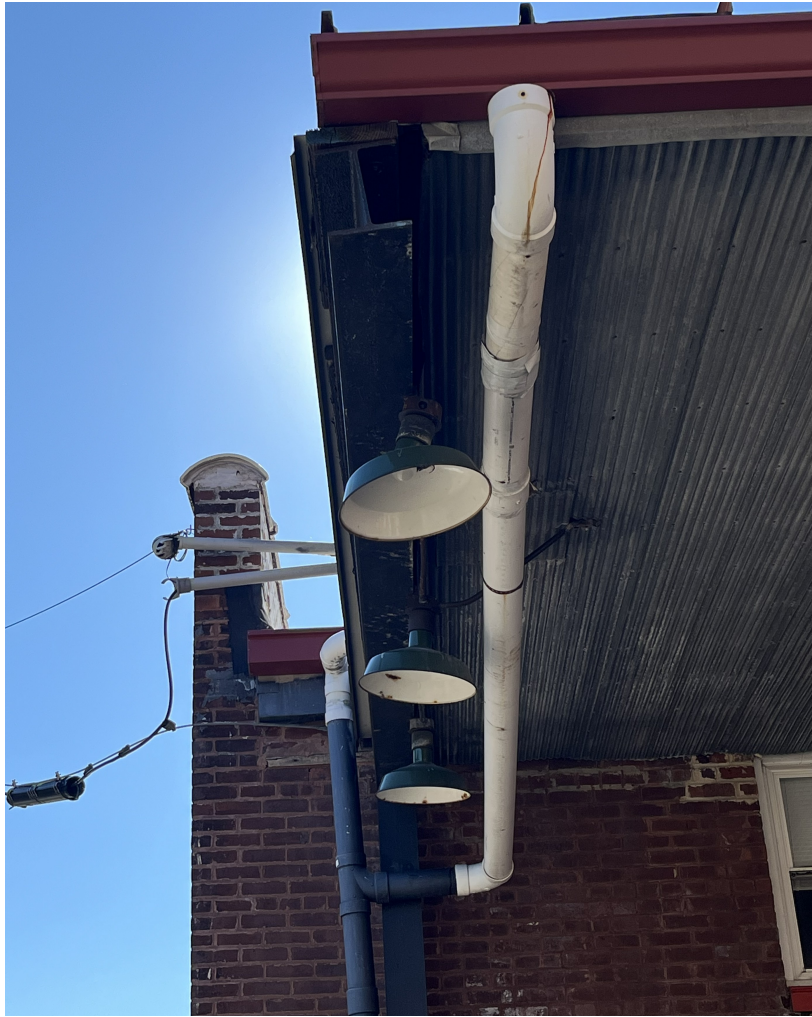
The beam located at the end of the awning was observed to be out of level and shows signs of movement, as shown in Exhibit 6. The beam does not appear to be adequately connected to the adjacent structure.

Exhibit 6: Out-of-Level Beam

6. Reconnect and properly level the end beam of the awning to ensure continuous load transfer and lateral stability.
7. Replace or repair the sections of decking showing significant rust. Inspect and seal all beam penetrations and connections to prevent further moisture intrusion.

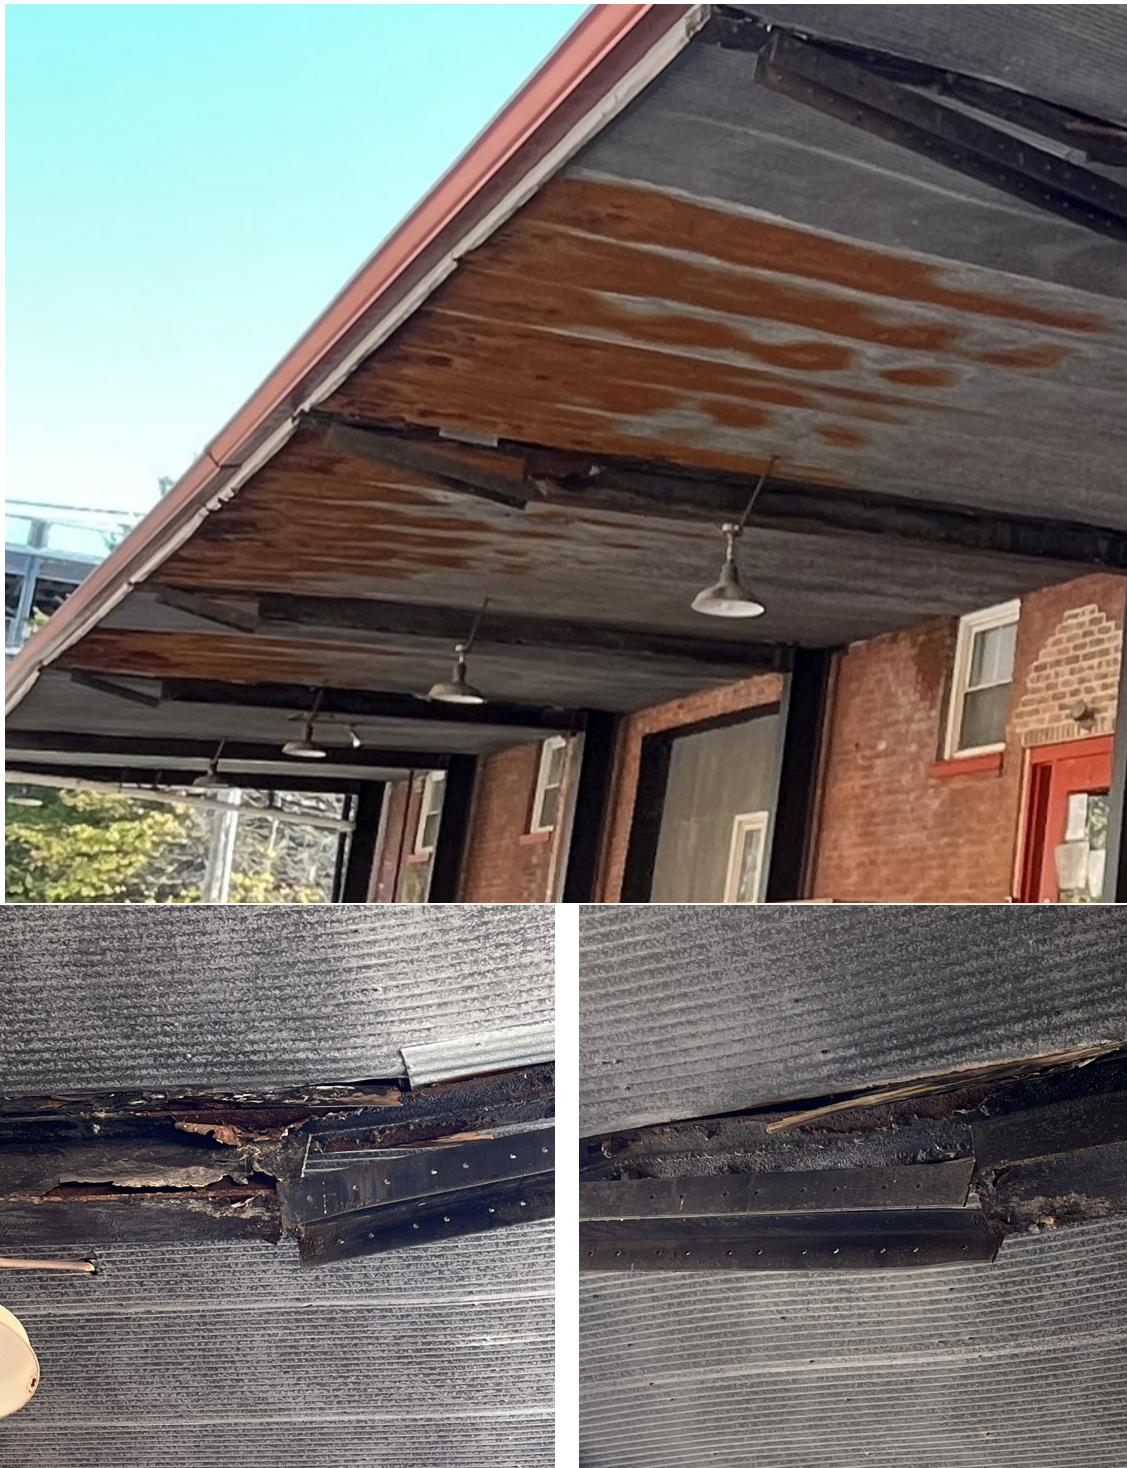
The majority of the metal decking associated with the awning system shows moderate to significant rusting. Rust and moisture were also observed near beam connections, seen in Exhibit 7, which may accelerate deterioration if left untreated.

Exhibit 7: Rusty Awning Decking and Beams
